First Five-Year Review Report
For Cannelton Industries, Inc. Site
Sault Ste. Marie, Chippewa County, Michigan
August, 2004

PREPARED BY:
U.S. Environmental Protection Agency
Region 5
Chicago, Illinois

Five-Year Review Report

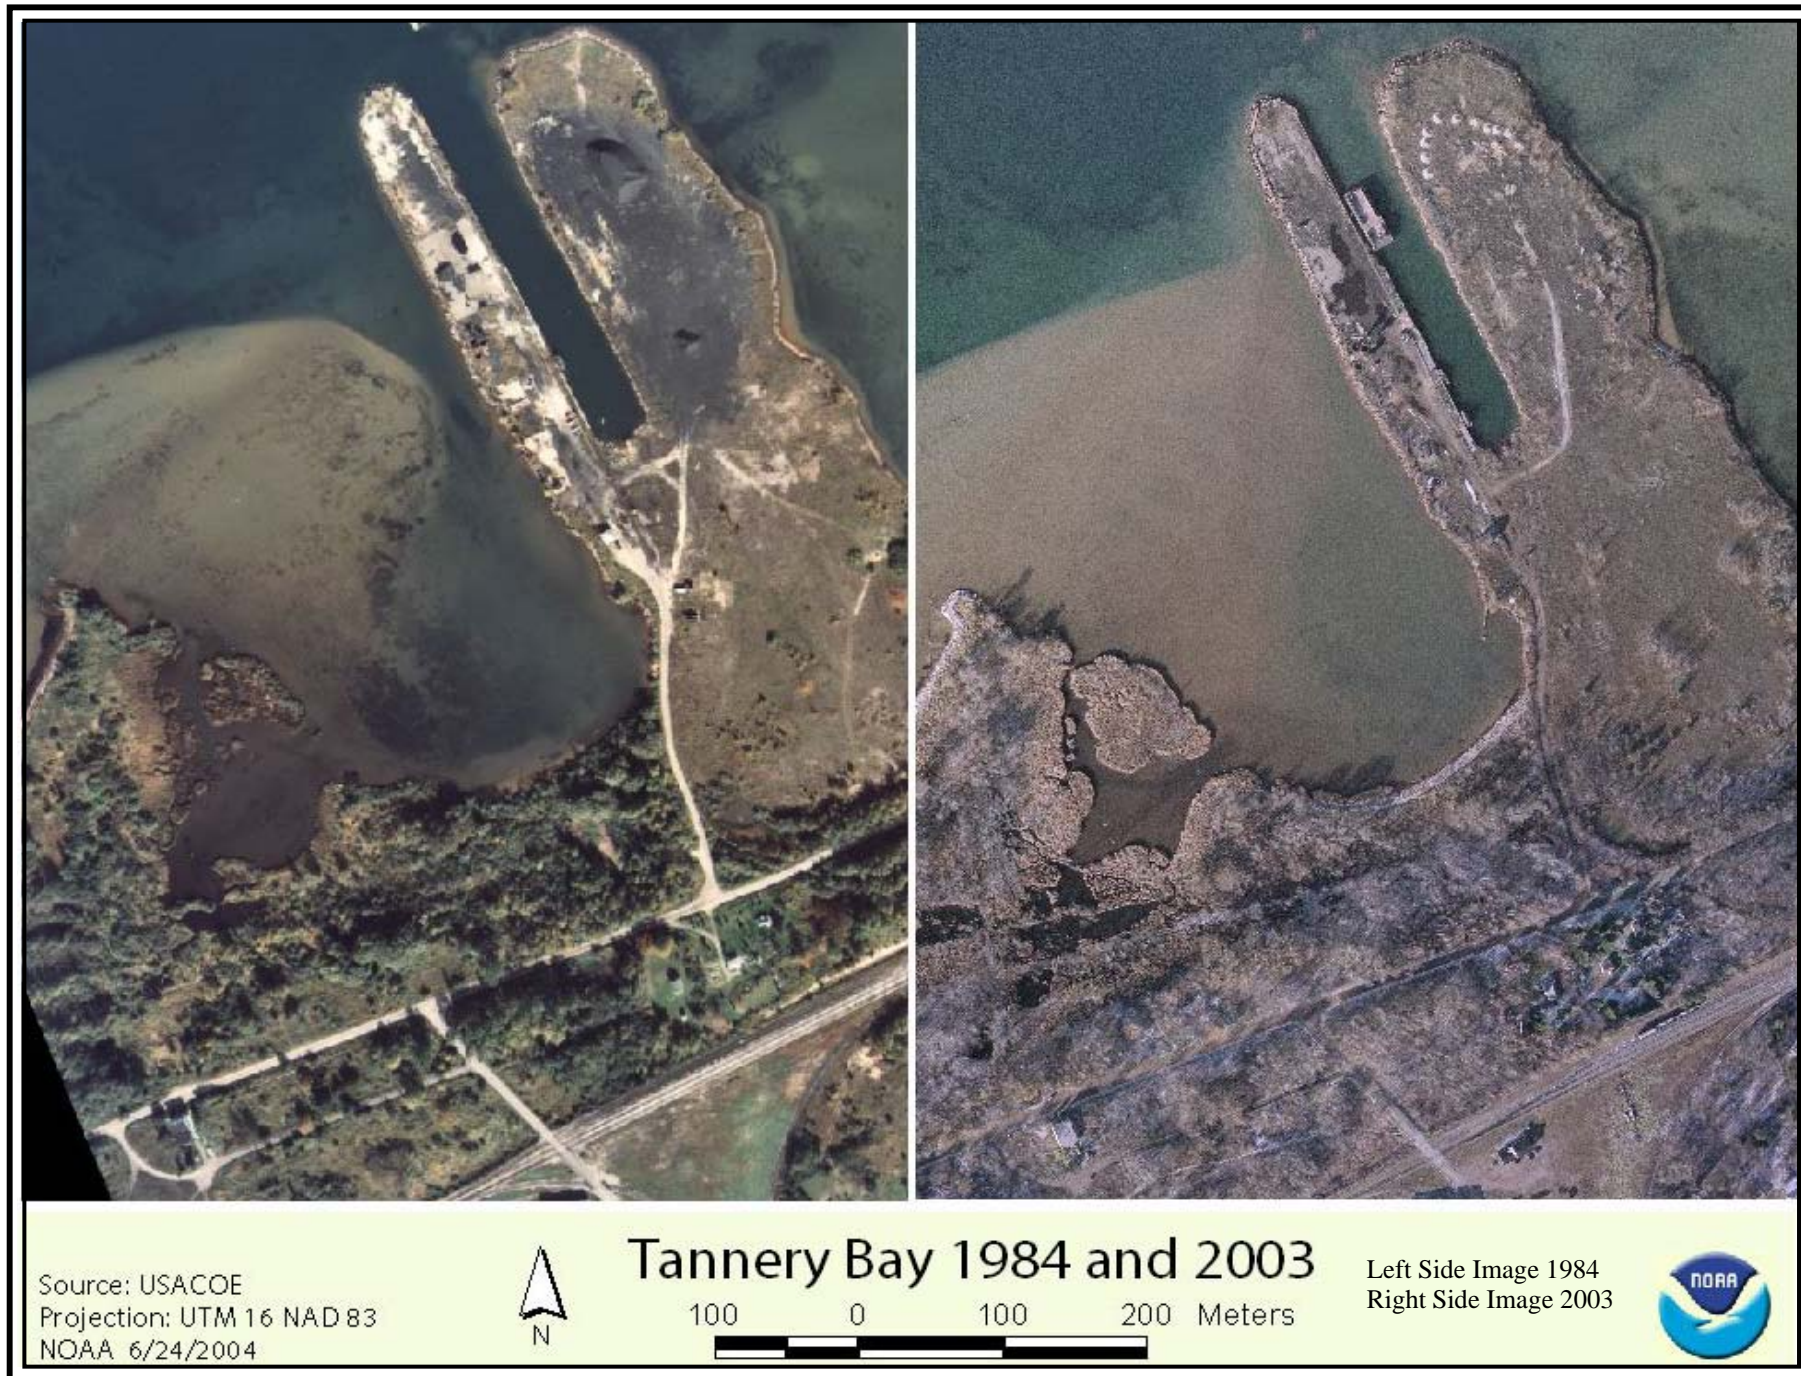
Figure 6. Tannery Bay, 1984 and 2003

The findings of this imagery analysis support the supposition in the Amended ROD that Tannery Bay is a net depositional area for sediment and the wetlands of Tannery Point are encroaching on the bay. This is reflected most dramatically by the transformation of 6.4 acres of deep bay to shallow bay, which includes the complete sedimentation of the former channel along the east shore of Tannery Bay, and the 1.7-acre wetland encroachment into the bay along the western and southwestern shores. As noted above, the entire area of the depression in the southeastern portion of Tannery bay was also noticeably shallower during the 2003 site inspection. In 1984, the channel between the large cattail island and the cattail wetland along Tannery Point was 19 meters wide. By 2003, wetland growth had decreased the channel width down to 2 meters. The analysis conclusively shows that Tannery

Bay is becoming shallower due to sediment deposition and decreasing in size due to wetland encroachment. While the assumptions of Tannery Bay being a net depositional area and the wetlands encroaching on the bay over the areas of contaminated sediment appear to be correct from this imagery analysis, additional questions regarding the effectiveness of the observed sedimentation and wetland encroachment on the anticipated decrease in bioavailability of site-COCs need to be addressed. As discussed above in the Tannery Bay Biological and Sediment Monitoring Section, the biological monitoring evaluation, when completed during the next 5-year review, will verify whether the increase in observed sedimentation and wetland encroachment translate into decreased bioavailability of site related COCs. Another question, concerning the potential trace element cycling by the cattails that are growing over the contaminated sediments is addressed in the next sub-section.
